This project began with the need to install a wheelchair lift within a very small lobby of an historic apartment building in Harvard Square.

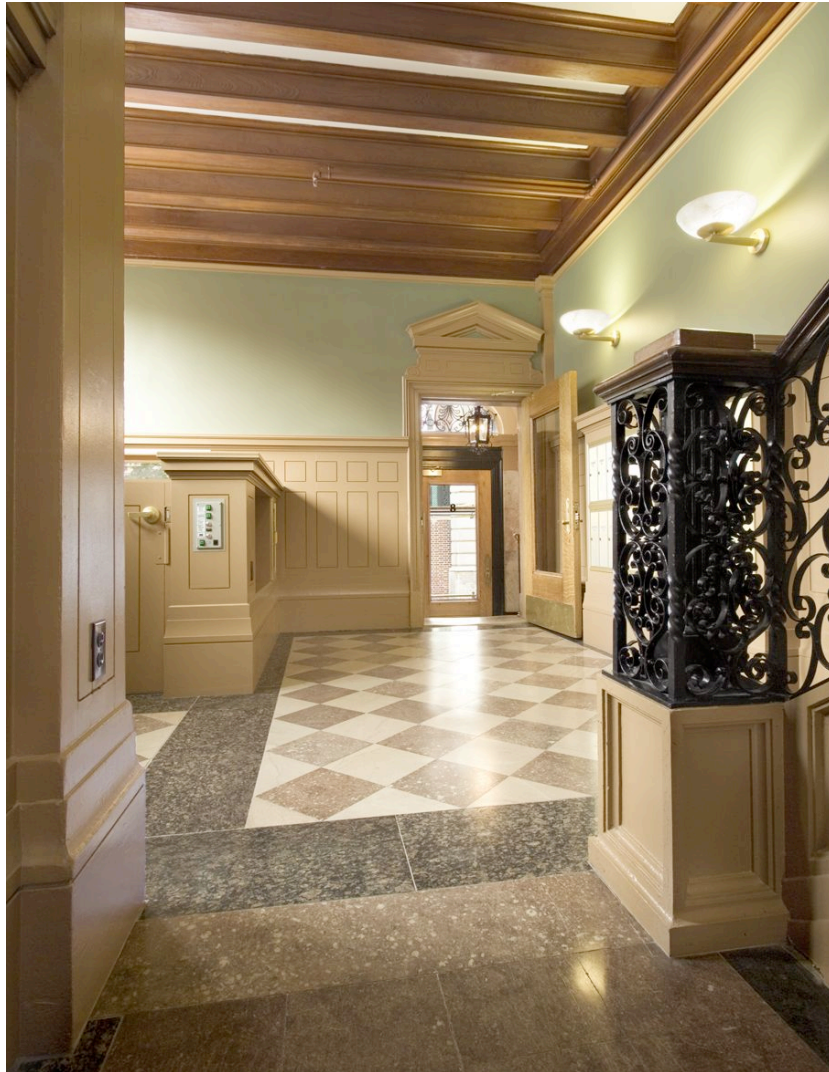
Although the lift occupied about one-quarter of the floor space (lift controls are visible at the center left of the photo), we were able to conceal it behind partial-height millwork walls, which extended the existing paneling.

The marble flooring was reworked to make sense of the new shape of the lobby; ad-hoc mailboxes were replaced; and sprinkler piping was reconfigured. New paint colors were based on historical analysis of the twelve layers of previous paint.

*Completed Fall 2003.*

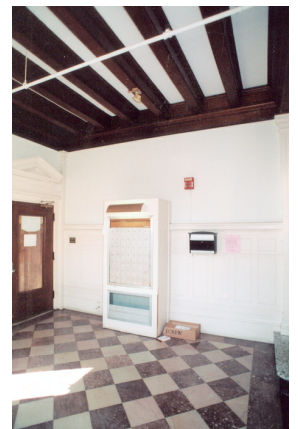
*Before renovation*
